SANTA BARBARA COUNTY CORONER

FACILITY AND EQUIPMENT

A Hazardous Environment

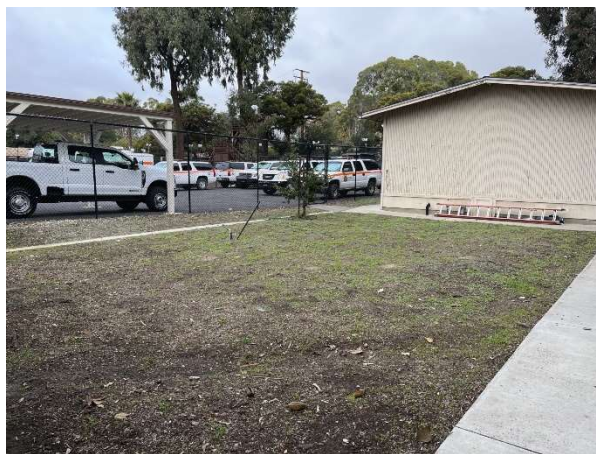
Empty Lot between Bldg. 1 and Bldg. 2

In cases when a severely decomposed body is delivered to the Coroner facility, a temporary, outdoor autopsy site must be set up behind the building to avoid cross-contamination and to manage the emanating odors (see photo above). An enclosed second autopsy suite has been requested by the Coroner’s Bureau but has not been approved by the Sheriff or Board of Supervisors.

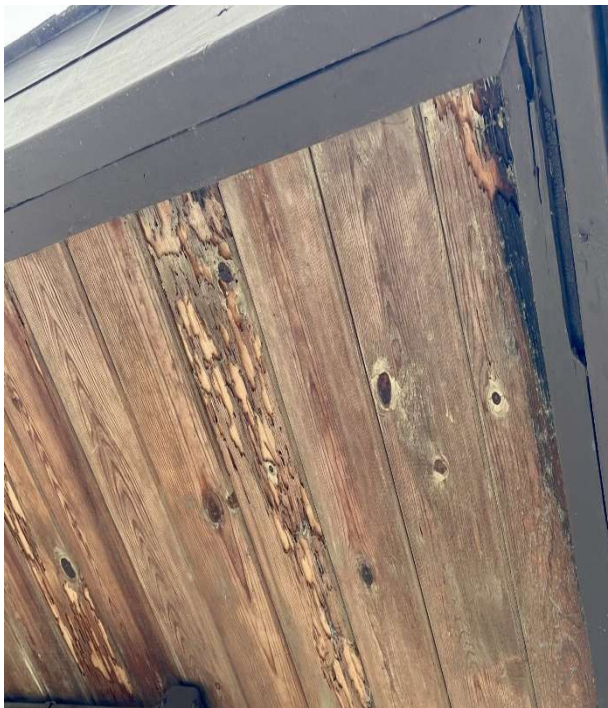
The Jury was informed the roof of the front building requires replacement; however, only the section above the bathroom was approved for repair after the inspector fell through an existing hole. The hole was repaired, but the job was only partially done and there remains a large opening in the ceiling. Multiple requests to replace the entire roof have been denied. In addition, there is visible evidence of termite damage in the eaves and roof line and probable wood rot.

Termite damage and wood rot (Bldg. 1)

Recommendation 1c: The Jury recommends a licensed professional exterminator be hired to assess whether there is active termite infestation and, as necessary, tent both structures. Additionally, the exterminator must perform all required sectional work to repair or replace all the termite-damaged areas. Repairs shall be completed by the end of the third quarter of calendar year 2024 or sooner.

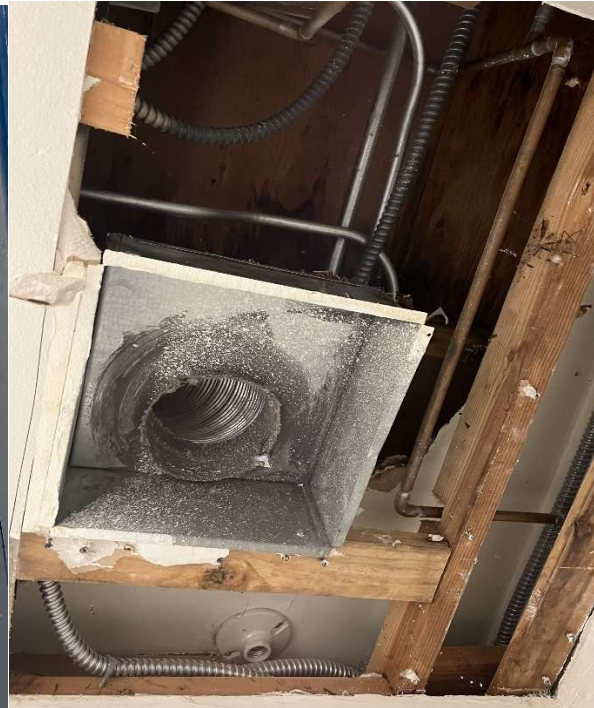
View of the bathroom ceiling in Bldg. 1

Recommendation 1a: The Jury recommends the installation of new roofing, including the replacement of accompanying support beams as needed, by a licensed roofing contractor, and not by handyman employees or janitorial staff from the Sheriff's Office or General Services. Repairs shall be completed by the end of the third quarter of calendar year 2024 or sooner.

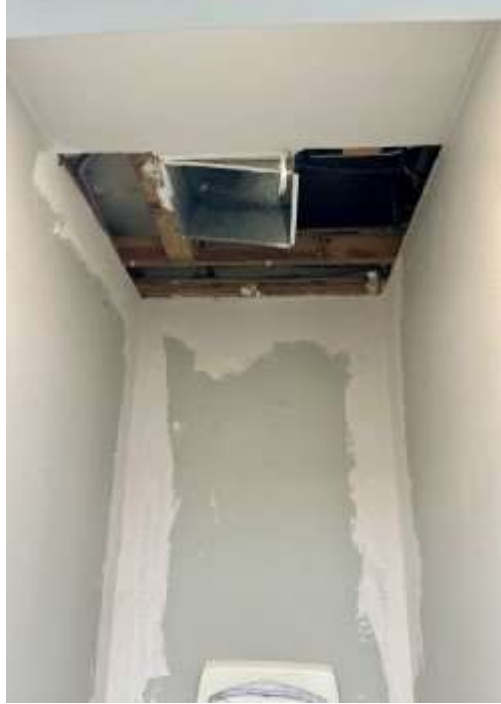
Another view of the bathroom in Bldg. 1

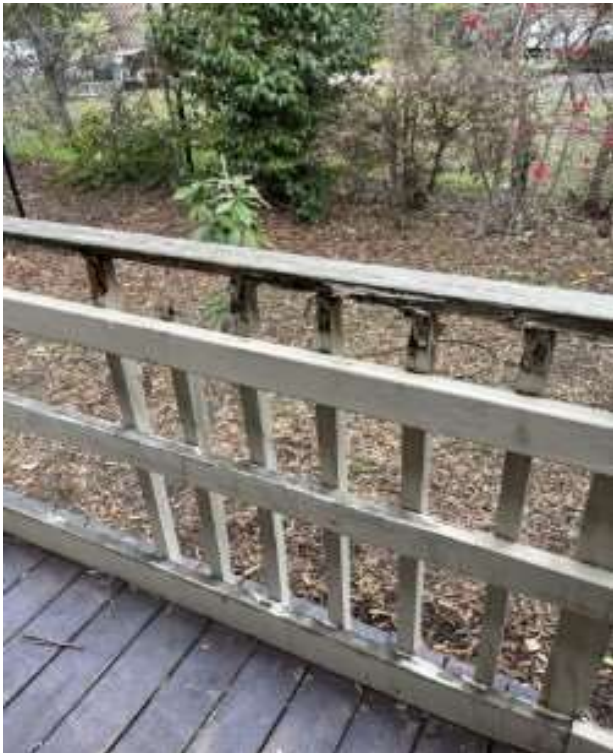
During the Jury's investigation, it also learned that the detective's office area in the Coroner's building is in deplorable condition. There is visible evidence of water intrusion, possible mold, and significant wood rot.

Rotted handrail outside Bldg. 2

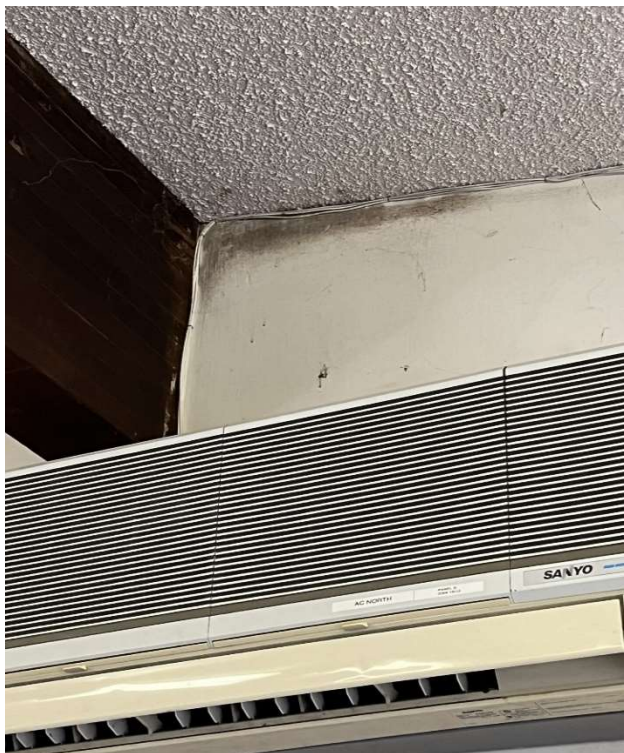
Evidence of water intrusion and possible mold in Bldg.2

Recommendation 1b: The Jury recommends a licensed professional mold abatement contractor be hired to assess whether there is active mold and, as necessary, conduct all required eradication efforts. Repairs shall be completed by the end of the third quarter of calendar year 2024 or sooner.

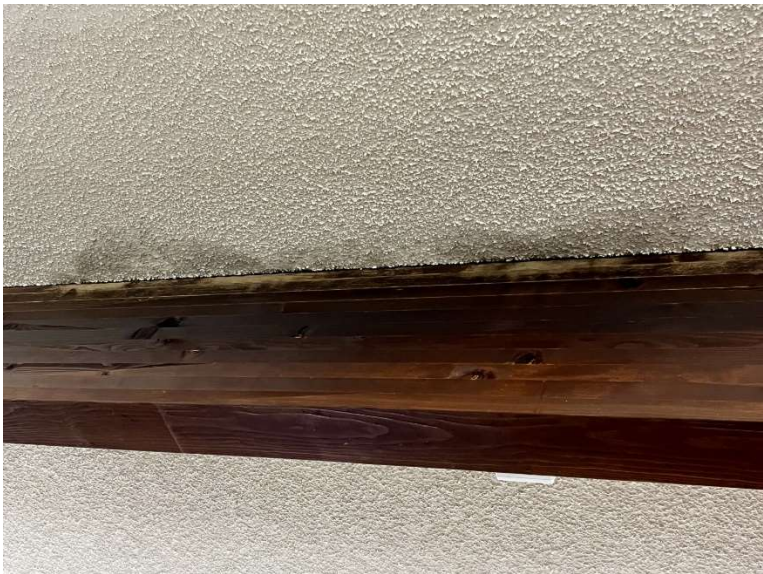
More evidence of water intrusion and possible mold in Bldg.2
